Inspection Report

440 Bonifay Dr
Hampton VA 23666

Complete Home Inspection, LLC

Date: 1/10/2021	Time: 01:30 PM	Report ID: 20210110-440-Bonifay-Dr
Property: 440 Bonifay Dr Hampton VA 23666	Customer: Joe Smith	Real Estate Professional:

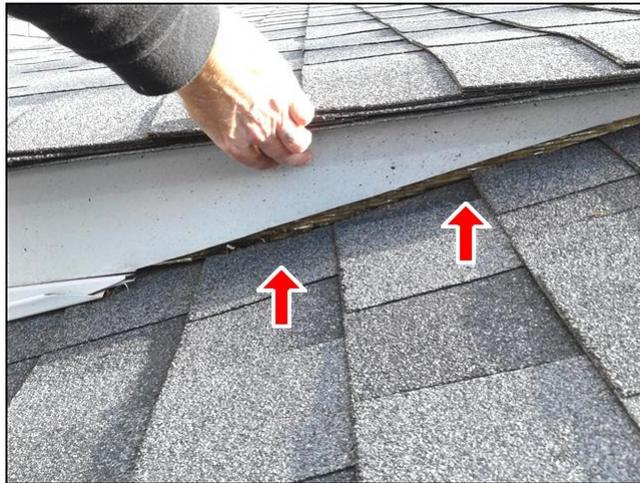
1.2 Item 3(Picture)

1.2 (2) An area on the rear shed-style roof of the addition, lacked adequate clearance between the trim and roofing materials, and appeared to lack adequate flashing. This condition is improper and may increase the chance of leakage with the potential for damage to cause roof structure damage from wood decay, damage home materials, or create unhealthy conditions by encouraging microbial growth such as mold.

To avoid damage to the underlying roof structure or home materials from moisture intrusion, the inspector recommends flashing should be evaluated and repaired by a qualified roofing contractor.

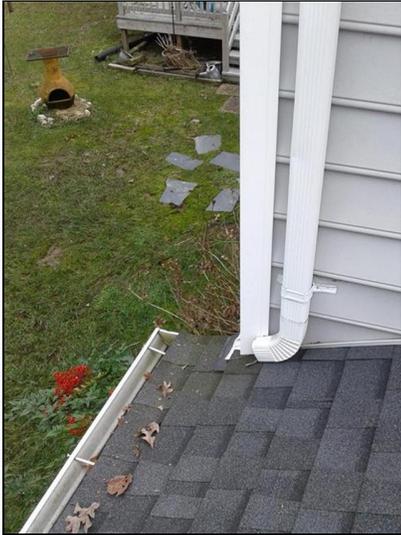
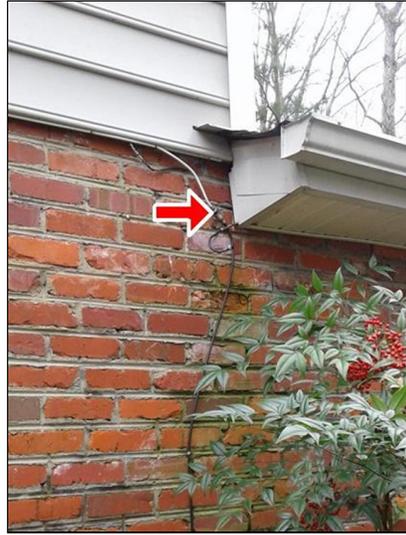
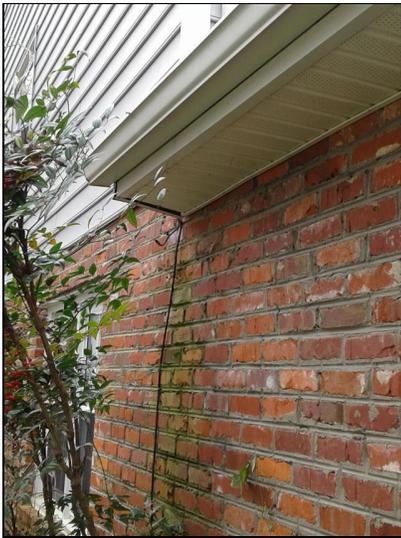
1.3 (1) One or more downspouts discharged roof drainage next to the foundation. This condition can effect the ability of the soil to support the weight of the structure above and can cause damage related to soil/foundation movement. The Inspector recommends the installation of downspout extensions to discharge roof drainage a minimum of 6 feet from the foundation.

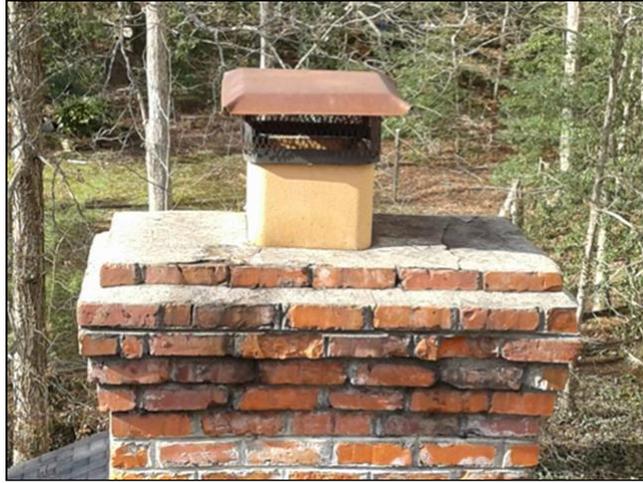
1.5 Item 1(Picture)

1.5 Moderate cracking visible in the chimney crown should be repaired, or the crown replaced, to prevent worsening damage caused by moisture in the cracks expanding as it freezes. All work should be performed by a qualified chimney sweep or contractor.

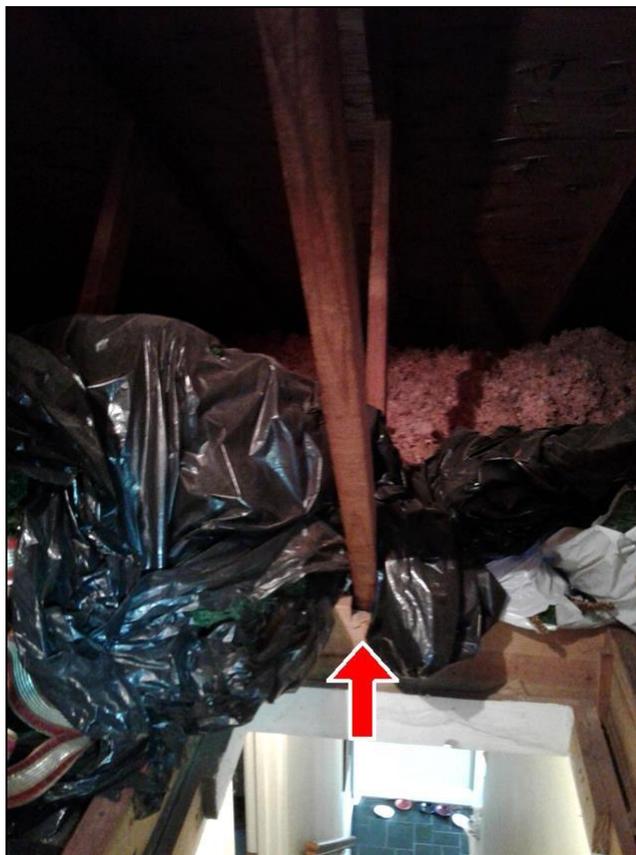
2.1 Item 1(Picture)

2.1 A roof truss which had been cut (for a pull-down staircase) was visible in the attic. Trusses must never be structurally altered without design, inspection and approval by a structural engineer. The Inspector recommends further evaluation by a structural engineer, and repair by a licensed contractor if required.

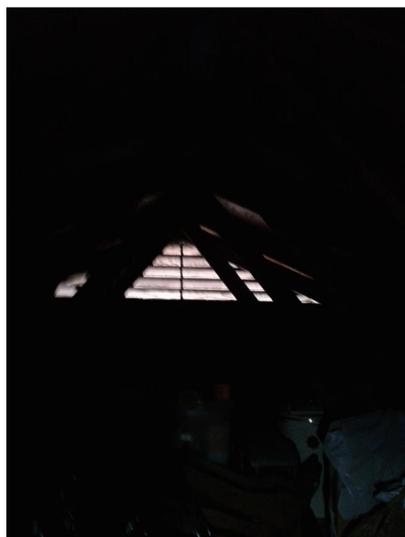
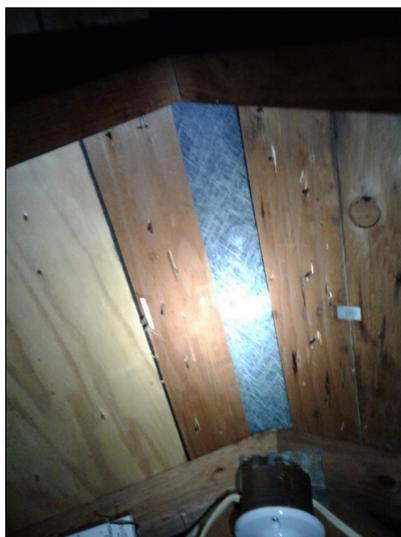
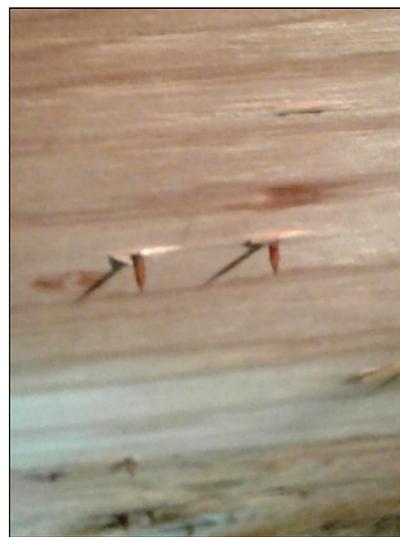
2.3 While both gable vents [Item 1(Picture)] and ridge vents [Item 2(Picture)] were present, surface rust on roofing nails [Item 3(Picture)] indicates a buildup of moisture/humidity which is usually a result of insufficient venting. The Inspector recommends that you consult with a licensed contractor for further evaluation of ventilation and repair.

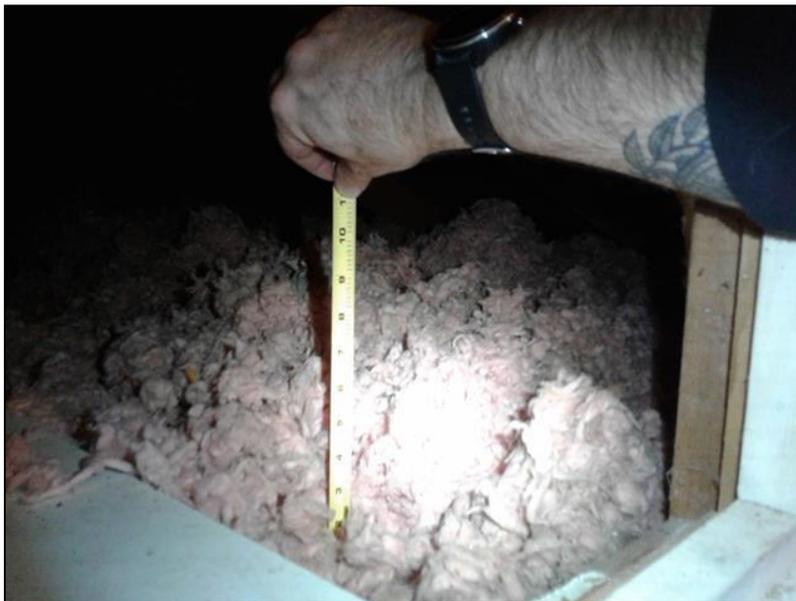
2.5 Item 1(Picture)

2.5 (1) The attic floor insulation depth averaged approximately 6 to 8 inches. The Inspector recommends installing additional insulation to comply with local energy codes

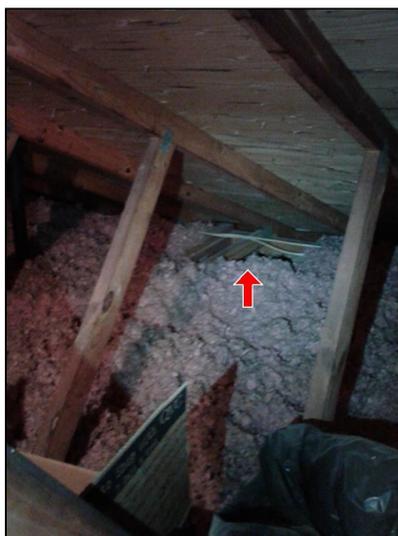
2.5 Item 2(Picture)

2.5 (2) The attic was missing insulation in some areas. This condition can result in increased heating and cooling costs, reduced comfort levels and may contribute to ice damming of the roof during the winter. The Inspector recommends that insulation be properly distributed to cover all portions of the attic located above the home living space.

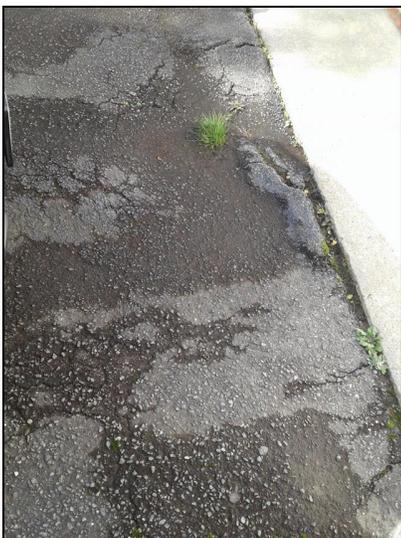
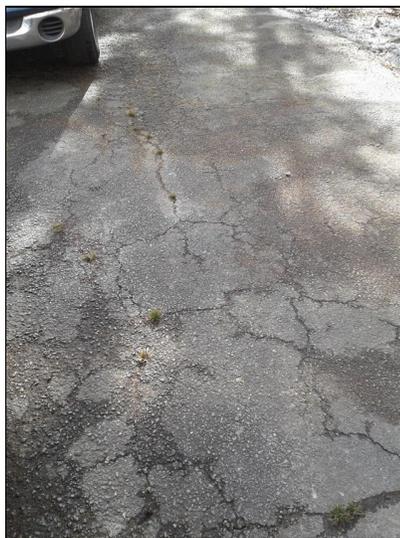
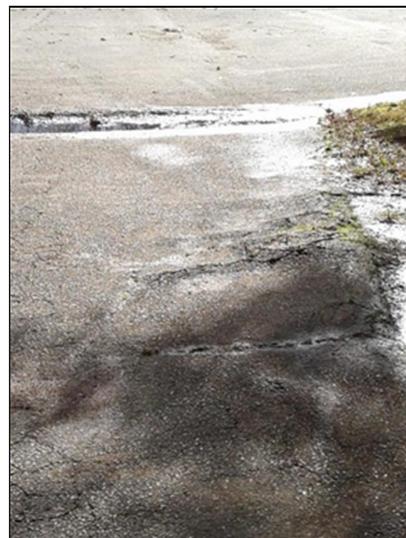
3.1 The driveway was severely deteriorated and needed extensive work at the time of the inspection. The Inspector recommends consulting with a qualified contractor to discuss options for repair.

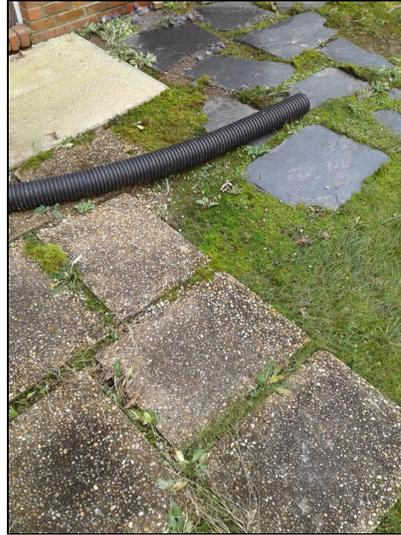
3.2 Item 1(Picture)

3.2 Rear paver stones and slate were at varying heights, potentially causing a trip hazard. The Inspector recommends repair or replacement.

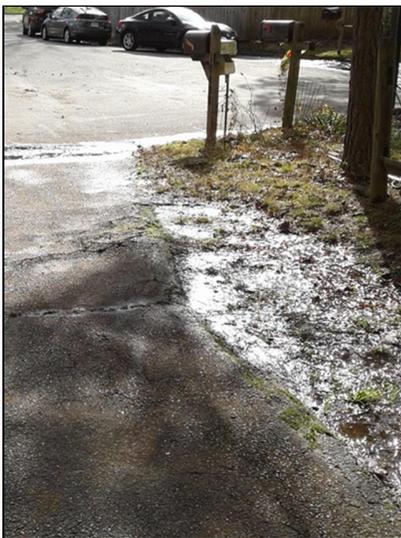
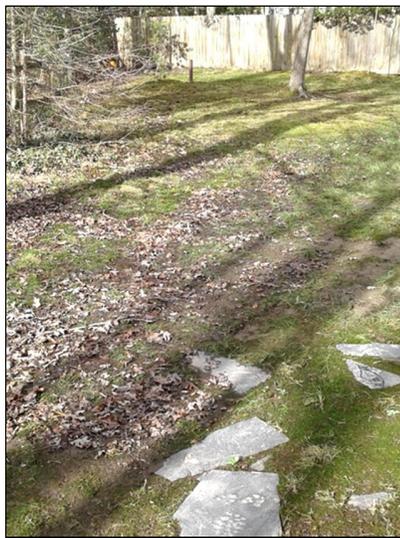
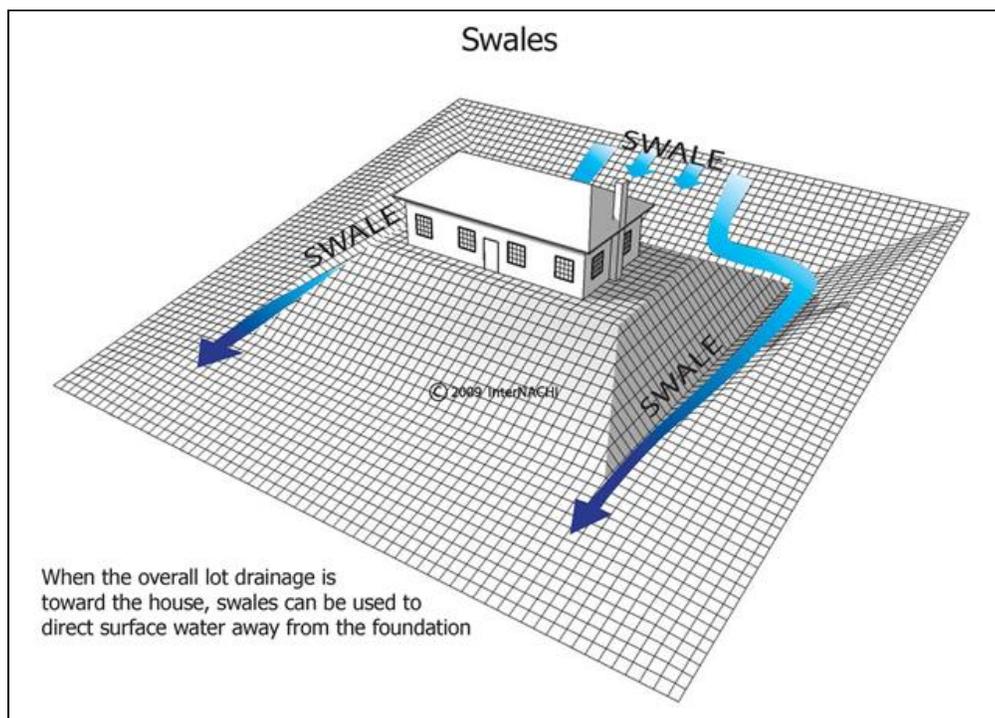
3.3 The home had areas of neutral or negative drainage that will route runoff from precipitation toward the foundation. Excessively high moisture levels in soil supporting the foundation can effect its ability to support the weight of the structure above. The ground should slope away from the home a minimum of ¼-inch per foot for a distance of at least six feet from the foundation.

The Inspector recommends further evaluation and repair by a licensed contractor, for possible re-grading to improve drainage near the foundation, and adding swales [Item 3(Picture)] to direct water away from the home.

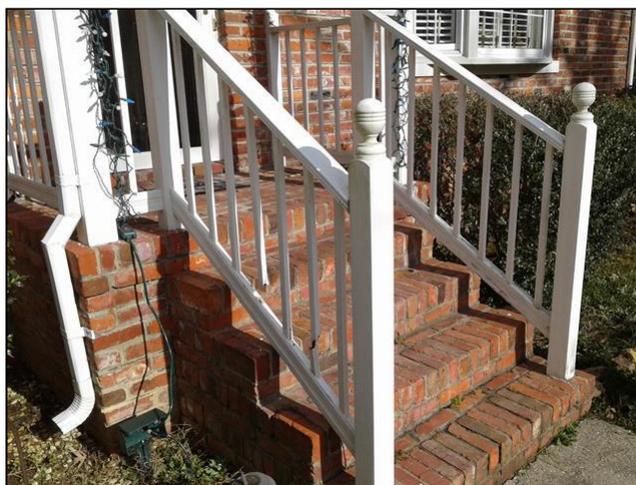
3.5 Item 1(Picture)

3.5 At the time of the inspection, the porch guardrail assemblies had areas of moderate damage. Spaces between handrail assembly balusters exceeded 4 3/8 inches at the open side of this porch staircase. Safe building practices dictate that a 4 3/8-inch sphere may not pass through the handrail at any point. This condition may be hazardous to small children.

This staircase did not meet generally-accepted modern safety standards that specify the proper the size and dimensions of a grippable handrail.

The Inspector recommends repair or replacement by a qualified contractor.

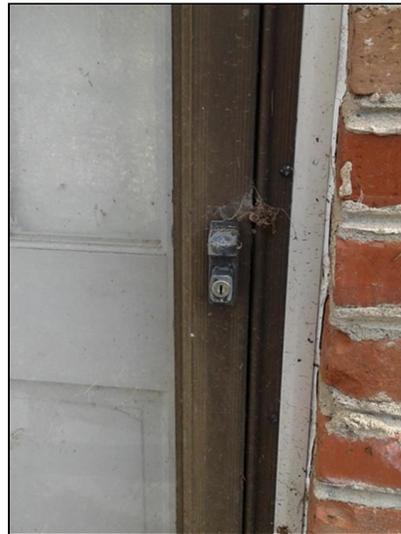
4.0 Item 1(Picture)

4.0 Garage storm door is missing handle. The Inspector recommends repair or replacement

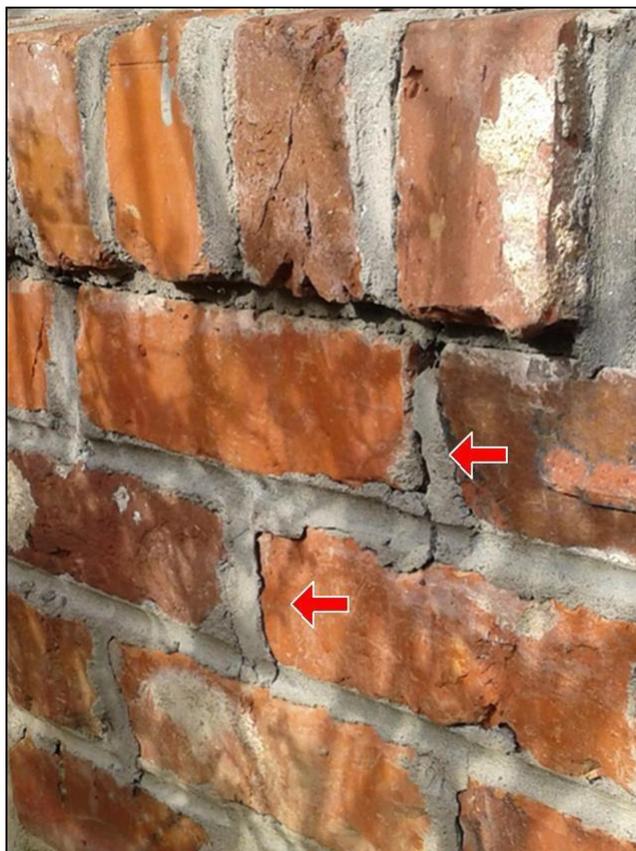
4.3 Item 1(Picture)

4.3 Stepped cracking visible in areas of the brick exterior under the left front window appeared to be the result of possible differential settlement due to moisture saturation of soil near the foundation. With certain soil types, excessively high moisture levels in soil supporting the foundation can reduce the ability of the soil to support the weight of the structure above, resulting in settling of soil beneath the affected portion of the foundation. The source of moisture appears to be due to grading and the area of the neighborhood.

The Inspector recommends that action be taken to control grading and drainage, getting water away from the home, and repair by a masonry contractor.

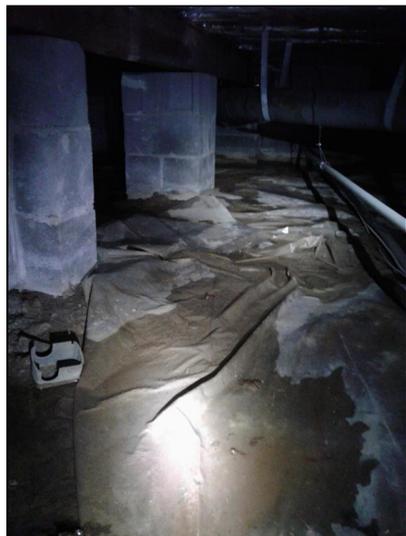
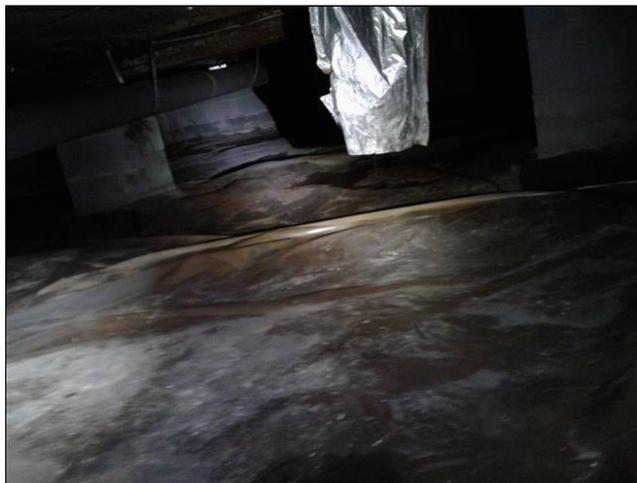
5.3 Water pooled in the crawlspace at the time of the inspection may damage the foundation or home structure by encouraging soil movement, affecting the ability of the soil to carry the weight of the structure above, or by causing wood decay. Moisture intrusion also encourages the growth of microbes such as mold fungi. This condition may result from surface runoff seeping under and/or through the foundation walls, but can also be caused by rising groundwater. Some areas of the crawlspace were inaccessible and unable to be fully evaluated due to standing water. The Inspector recommends consulting with a qualified contractor for grading and moisture control.

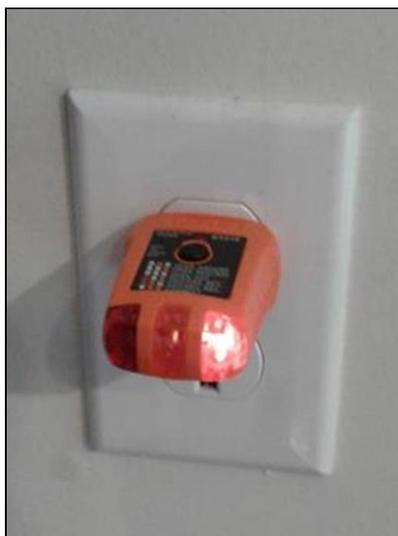
6.11 Item 1(Picture)

6.11 A electrical outlets near the rear sliding door tested as having an "open neutral," making the receptacle not function properly, and potentially leading to overheating and/or fire. The Inspector recommends correction by a licensed electrical contractor.

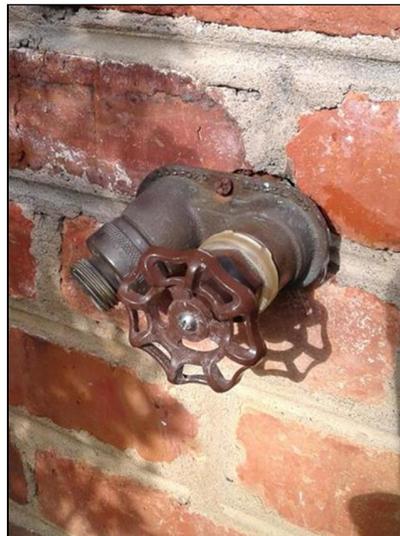
7.0 Item 1(Picture)

7.0 An exterior faucet at front of the house was inoperable. The Inspector recommends repair by a qualified plumbing contractor.

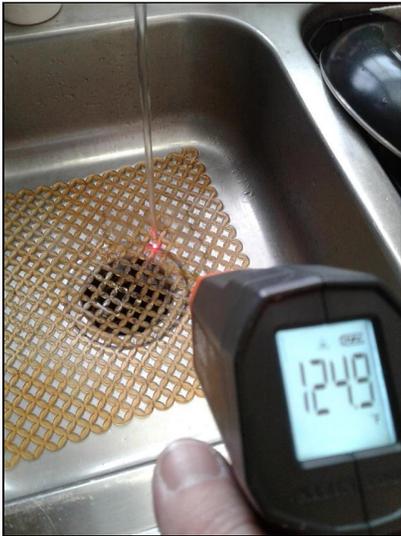
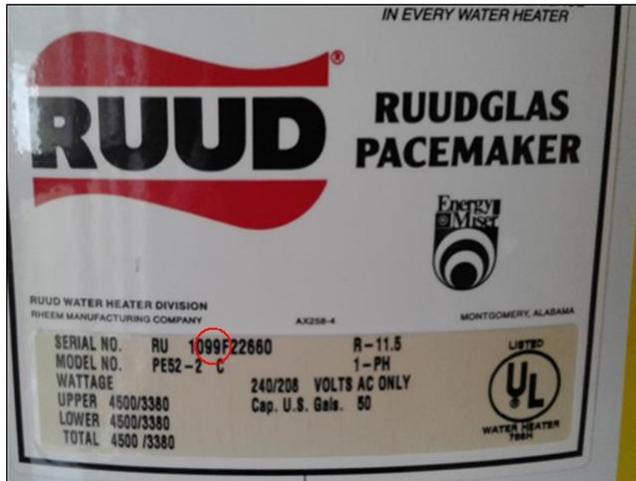
7.4 (1) The water heater was functioning at the time of inspection, appeared to be past its design life and may need replacement soon. This unit was manufactured in 1999, with the average age of a conventional water heater being 6-12 years

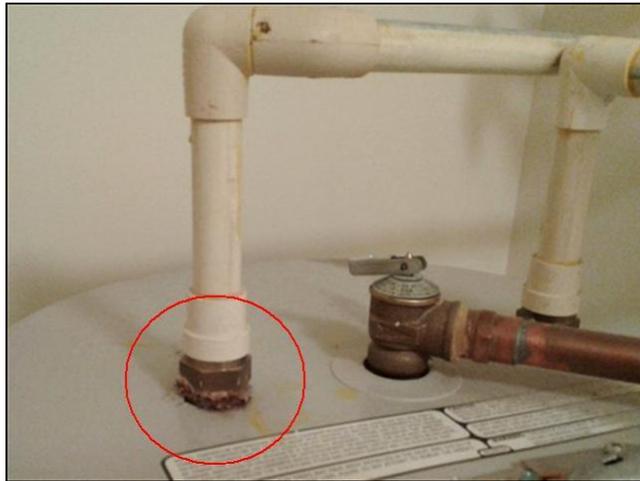
7.4 Item 3(Picture)

7.4 (2) Some corrosion was noted at a fitting on top of the water heater tank (possibly from a very small leak, or dissimilar metals.) The Inspector recommends evaluation and correction by a qualified plumber

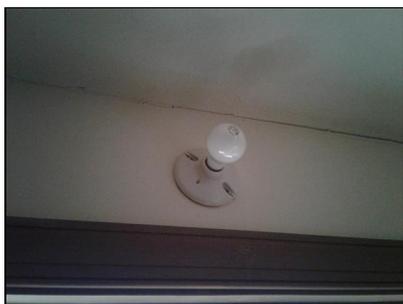
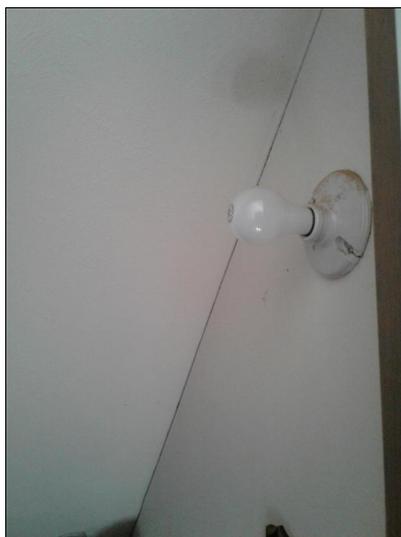
9.3.A Two downstairs closets had fixtures with exposed bulbs. These can be hazardous due to breakage, and a potential fire hazard if items are stacked or leaned against them. The Inspector recommends replacement by a licensed contractor

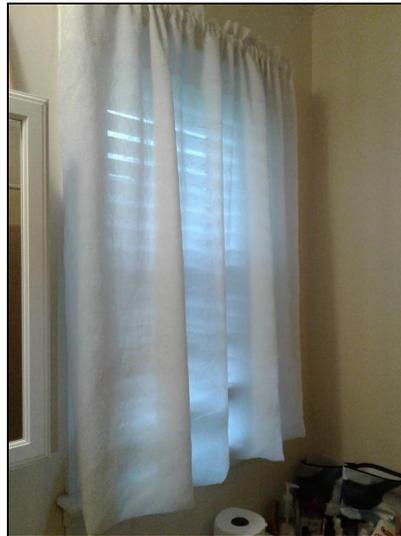
10.8.A Item 1(Picture)

10.8.A Though a window is present, no additional room ventilation was provided for the Primary Bathroom. To avoid poor conditions resulting from excessively moist air, The Inspector recommends installation of an exhaust fan by a qualified contractor.

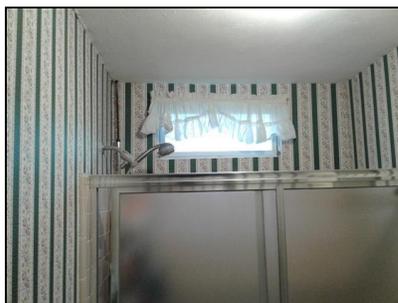
10.7.B Item 1(Picture)

10.7.B Though a window is present, no additional room ventilation was provided for Bathroom 2. To avoid poor conditions resulting from excessively moist air, the Inspector recommends installation of an exhaust fan by a qualified contractor.

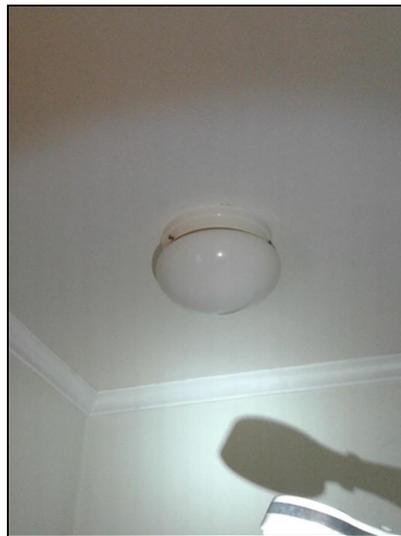
10.6.C Item 1(Picture)

10.6.C Light fixture in the shower was not functioning at the time of inspection. The Inspector recommends further evaluation (possibly a light bulb) or repair/replacement by a licensed electrician

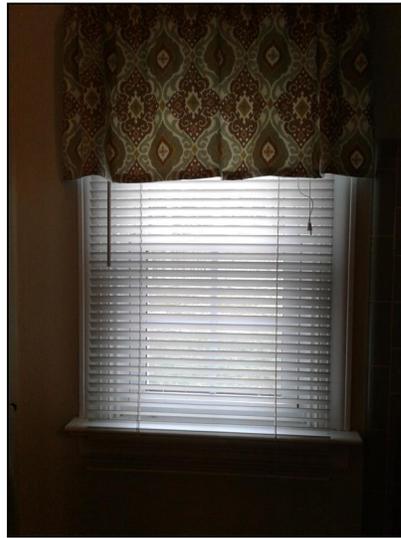
10.7.C Item 1(Picture)

10.7.C Though a window is present, no additional room ventilation was provided for the Bathroom 3. To avoid poor conditions resulting from excessively moist air, The Inspector recommends installation of an exhaust fan by a qualified contractor.

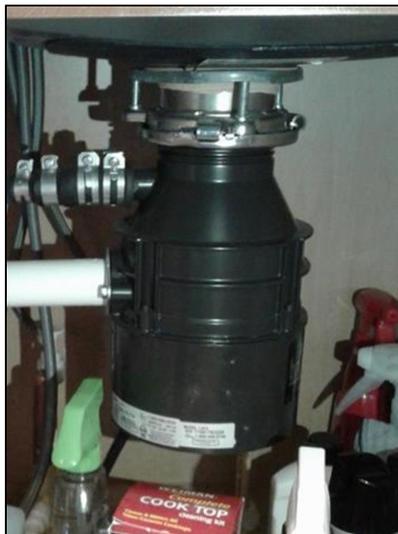
11.13 Item 1(Picture)

11.13 Garbage disposal not functioning at the time of inspection. Electricity to the unit was tested and sufficient. The Inspector recommends repair/ replacement by a licensed plumber.

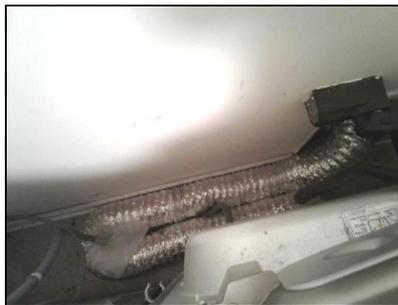
12.6 Item 1(Picture)

12.6 The dryer was vented using an expanding (accordion) vent that is not approved by the Underwriter's Laboratory (UL). This type of dryer exhaust vent is more likely to accumulate lint than a smooth metal vent, creating a potential fire hazard. Excessive lint accumulation can also increase drying time and shorten the dryer's lifespan. The Inspector recommends replacing this flex-vent with a properly installed, UL-approved dryer vent. All work should be performed by a qualified contractor.

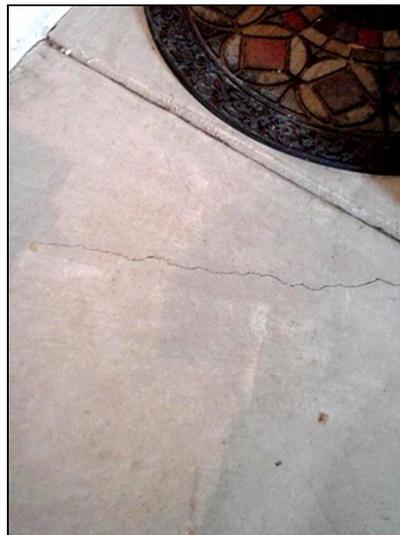
13.2 Item 1(Picture)

13.2 The garage floor had common shrinkage cracks. These cracks are not a structural concern.

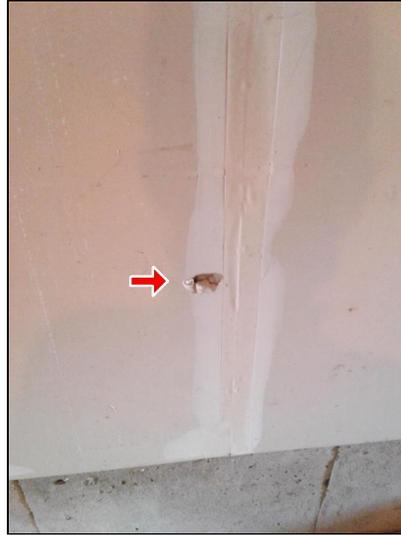
13.3 Item 1(Picture)

13.3 The garage walls had minor damage visible at the time of the inspection. These are considered "fire walls," providing a barrier between the garage and living space in case of fire. The Inspector recommends repair by a qualified contractor to insure proper fire separation
