Inspection Report

440 Bonifay Dr
Hampton VA 23666

Complete Home Inspection, LLC

Date: 1/10/2021	Time: 01:30 PM	Report ID: 20210110-440-Bonifay-Dr
Property: 440 Bonifay Dr Hampton VA 23666	Customer: Joe Smith	Real Estate Professional:

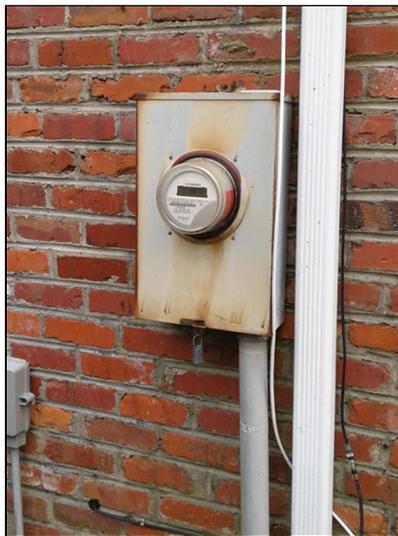
6.2 Item 1(Picture)

6.2 Electric meter located on the rear of the home

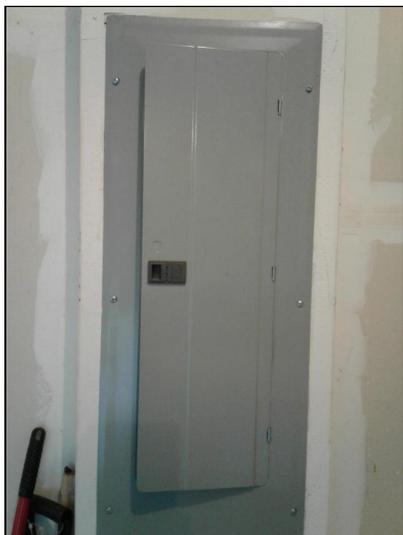
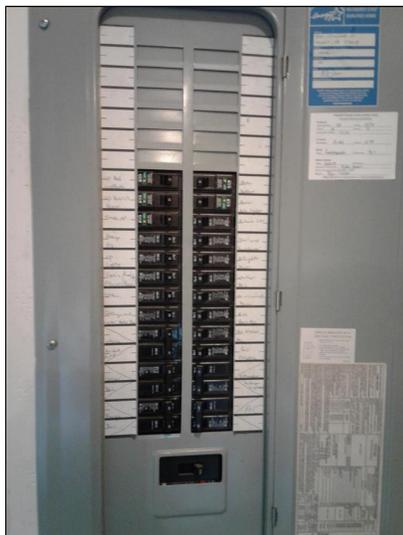
6.5 Electrical service (breaker) panel located in the garage

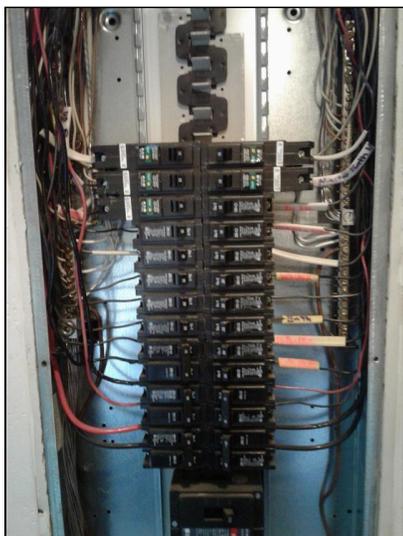
6.6 Item 1(Picture)

6.6 Panel wiring- Item 1(Picture)

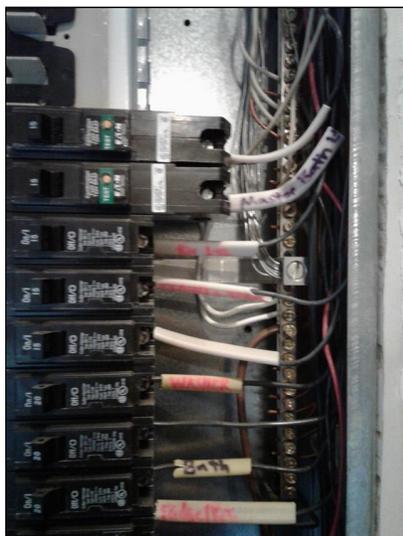
6.6 Item 2(Picture)

Ground/Neutral bus bar (right)- Item 2(Picture)

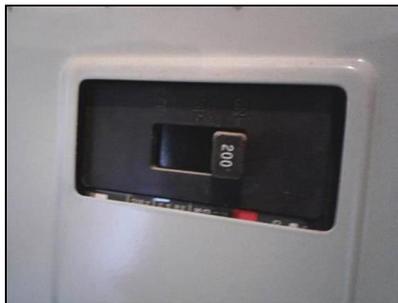
6.7 Item 1(Picture)

6.7 Electrical/power disconnect is located in the breaker panel

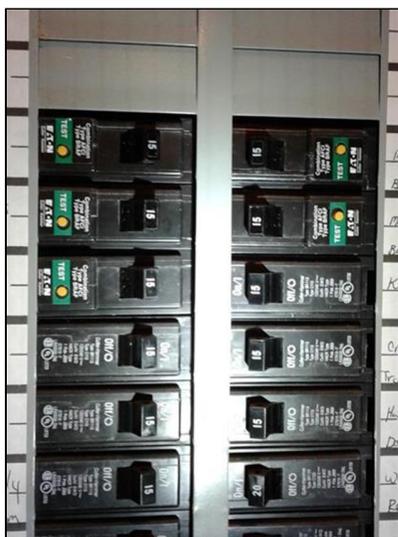
6.12 Item 1(Picture)

6.12 GFCI and AFCI breakers with resets (labeled green) are located in the main panel.

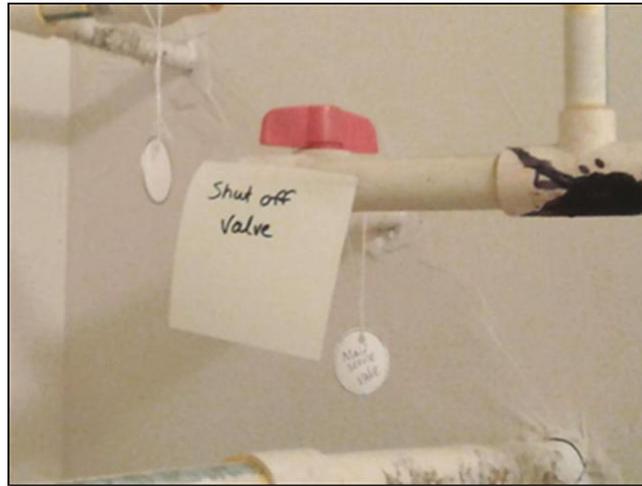
7.2 Item 1(Picture)

7.2 Main water shut-off located in the laundry closet

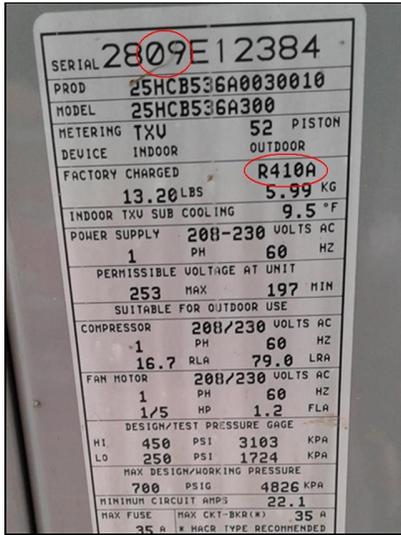
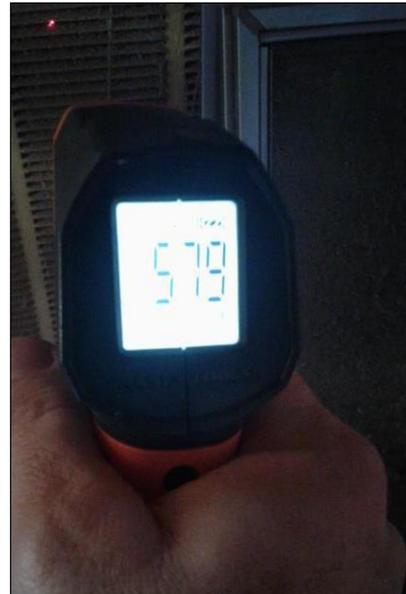
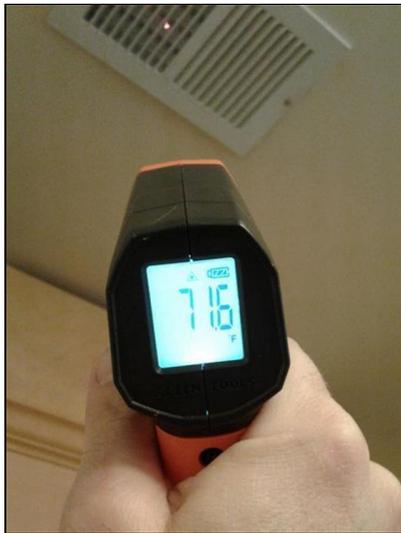
The cooling function was not tested because the outside temperature was below 67 degrees F. and to test it would

risk damaging the coils.
The Inspector recommends service by a qualified HVAC technician.

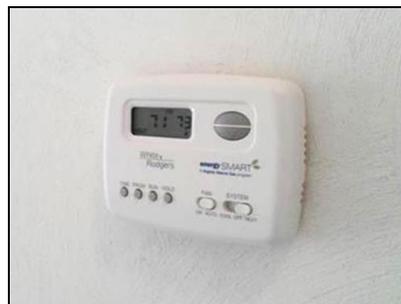
8.2 Item 1(Picture)

8.2 The home's thermostat is located in the upstairs hall

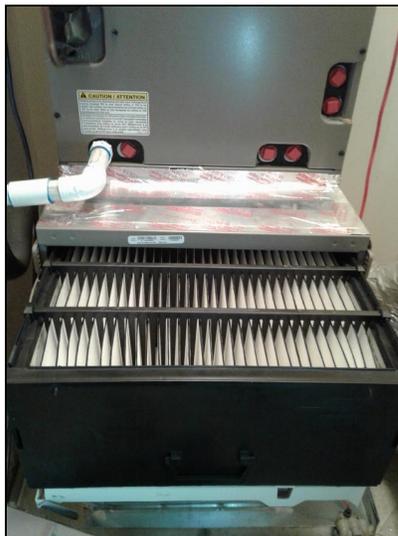
8.3 Item 1(Picture)

8.3 The air filter was clean at the time of inspection

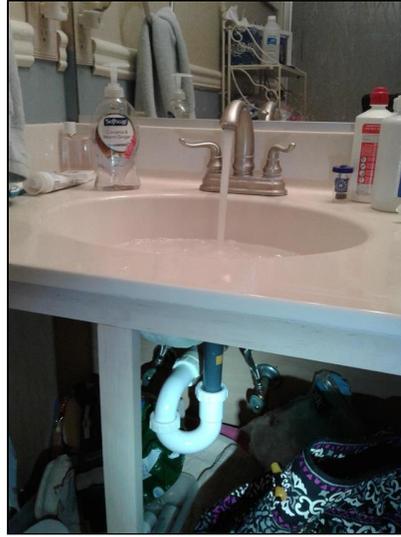
10.10.A Item 1(Picture)

10.10.A Tested- No leaks

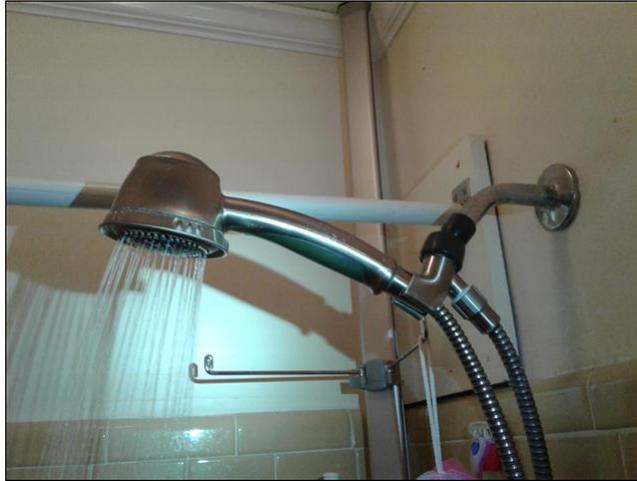
10.12.A Maintain the caulked seal between the walls and shower floor, to extend the lifespan of the shower.

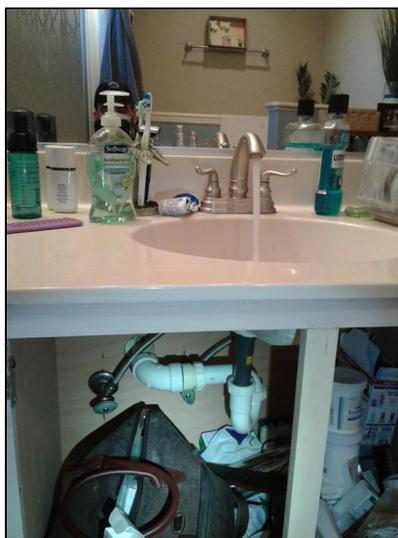
10.9.B Item 1(Picture)

10.9.B Tested- No leaks

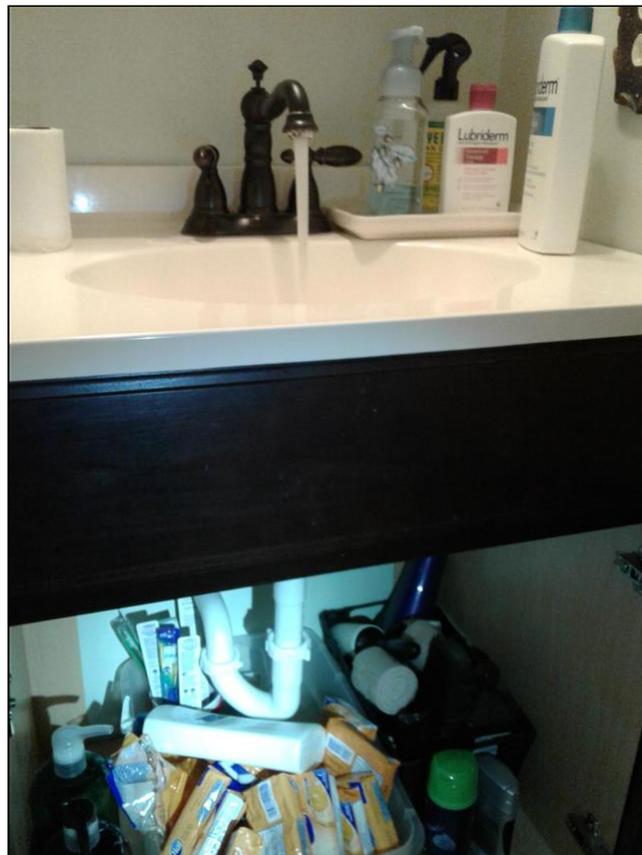
10.9.C Item 1(Picture)

10.9.C Tested- No Leaks

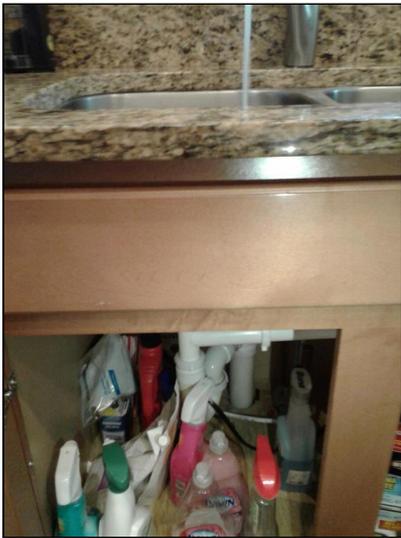
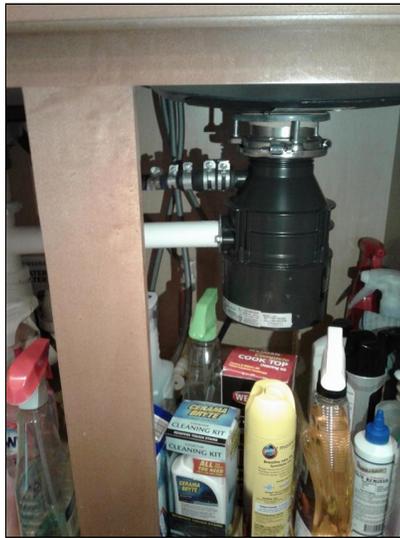
11.10 Both tested- No leaks
